METALS HANDBOOK

VOL. 9
FRACTOGRAPHY AND ATLAS OF FRACTOGRAPHY

8th EDITION

Fractography and Atlas of Fractographs

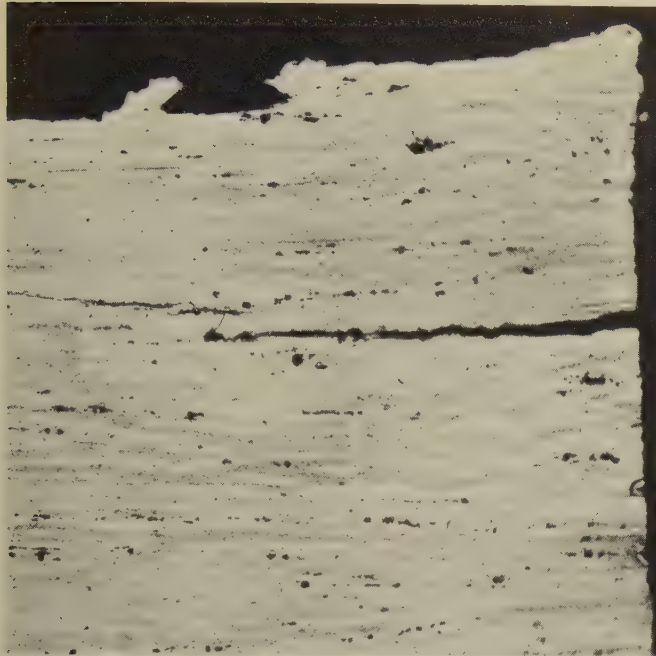
4654 Polished and etched section through the fractured aluminum alloy 7075-T6 fitting in 4653; fracture surface is shown in profile at top. The grains are very elongated, which facilitated propagation of both the primary fracture and the secondary cracks shown at midheight.

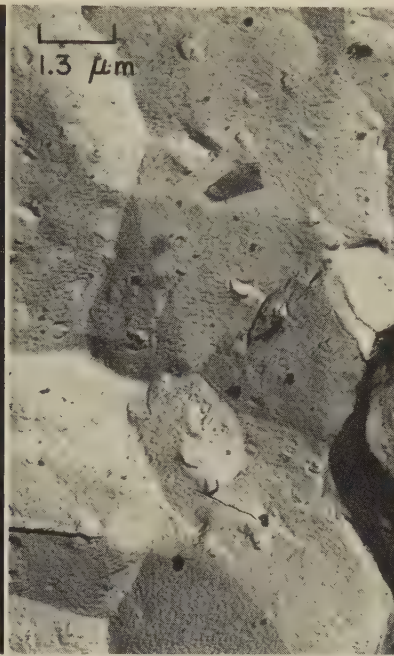
4655 TEM replica of an area of the stress-corrosion fracture surface in 4653, showing characteristic separated-grain facets coated with corrosion products.

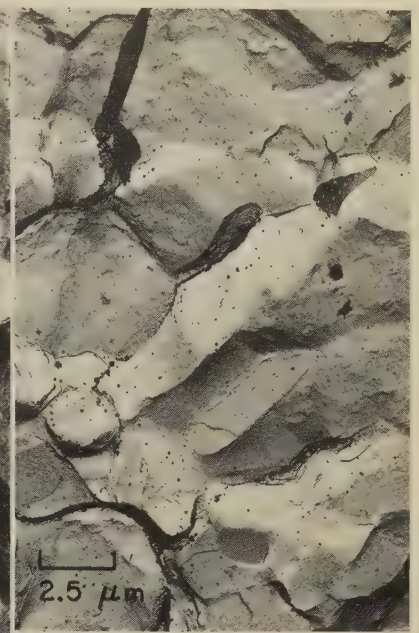
4656 TEM replica of another area in 4653, similar to that in 4655, but also showing secondary cracks between grains, which are also characteristic of stress corrosion.

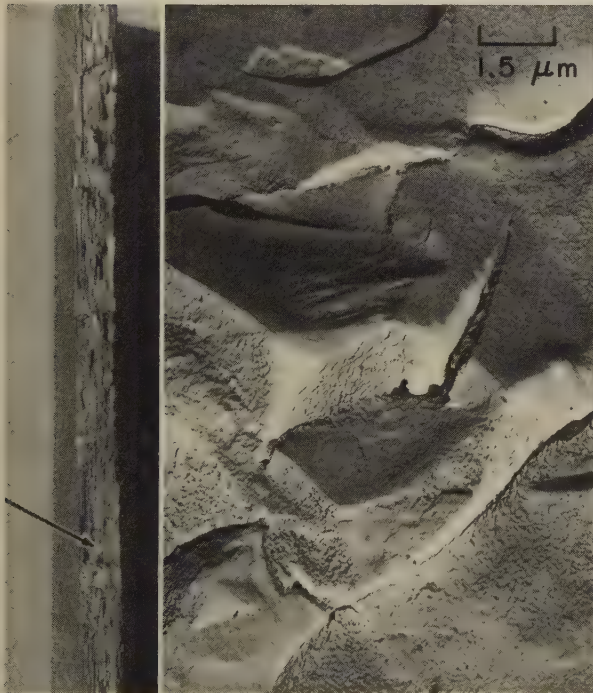
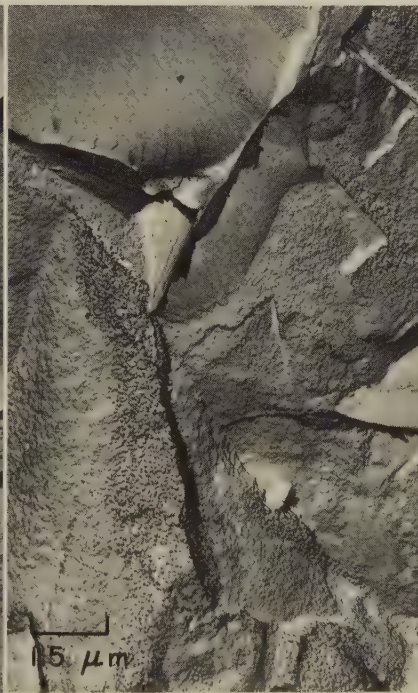
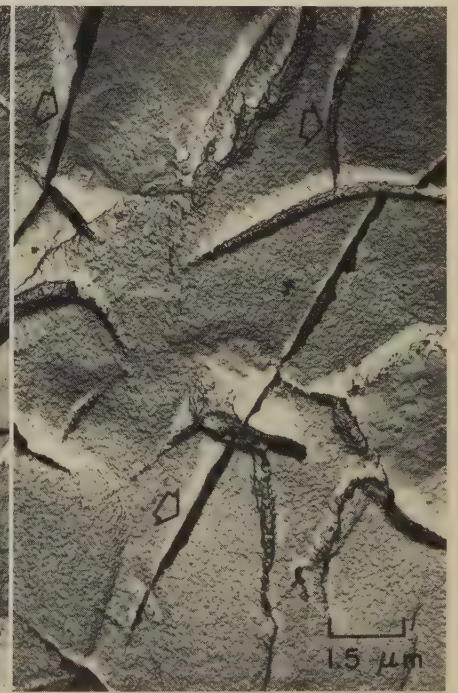
4657, 4658, 4659, 4660 Fractograph 4657 (left) shows a stress-corrosion fracture in a hoop specimen of forged aluminum alloy 7075-T6 (tensile strength, 614 MPa or 89 ksi) stressed in the short-transverse direction at 372 MPa (54 ksi) while exposed to a marine atmosphere. Fracture occurred after 16 days. Fractographs 4658, 4659 and 4660 show TEM replicas of three areas at the arrow in 4657. Fractograph 4658 (second from left) shows separated-grain facets coated with corrosion products, smooth regions that may be facets of cleaved second-phase particles, and a few "mud cracks". Fractograph 4659 (second from right) shows an area similar to that in 4658, but with longer "mud cracks". The area shown in 4660 (right) lacks the smooth regions visible in 4658 and 4659, contains an even more sharply defined "mud crack" pattern (at arrows), and appears to consist of transgranular facets.

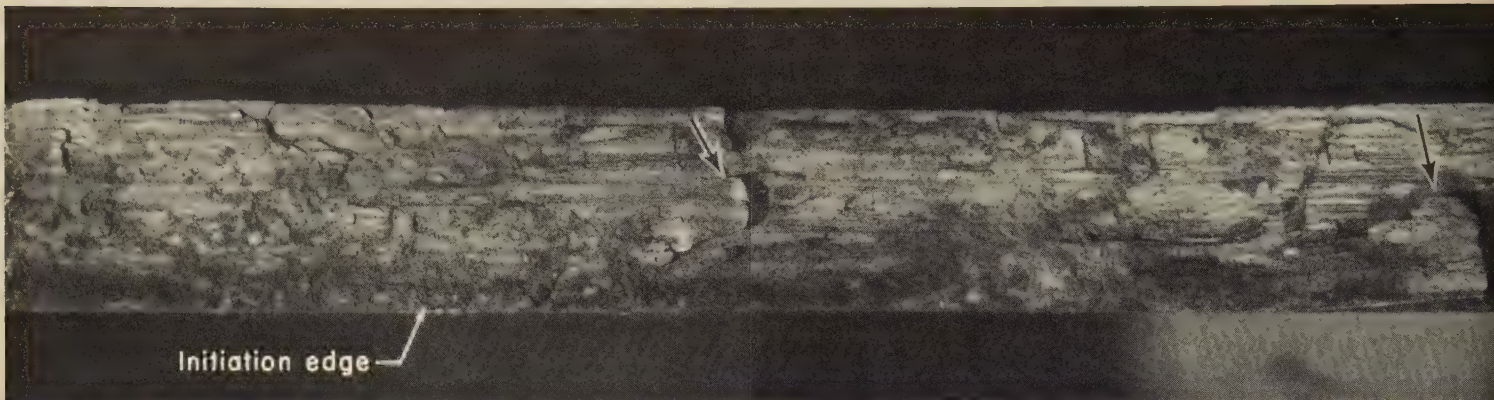
4661 Surface of a fracture in an aircraft lower-bulkhead cap fabricated from an extrusion of aluminum alloy 7075-T6. The cap was cut open to expose the fracture for inspection, and evidence of corrosion was found along the edge at which fracture was initiated (bottom edge in this view). Secondary cracks had produced "leaves" (at arrows) in the fracture surface. See also 4662 to 4670 (below, and on facing page).

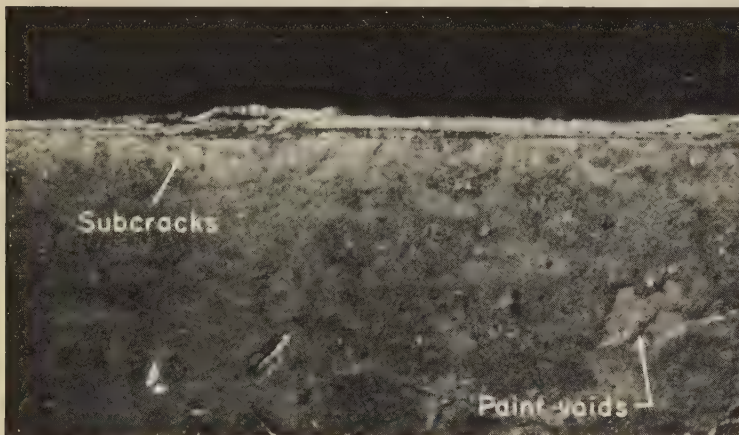
4662 A portion of the painted external surface of the fractured aircraft lower-bulkhead cap in fractograph 4661, showing a profile of the fracture surface (at top) and voids in the paint film. Subcracks are evident immediately below and parallel with the fracture surface. Compare with 4663 (right).

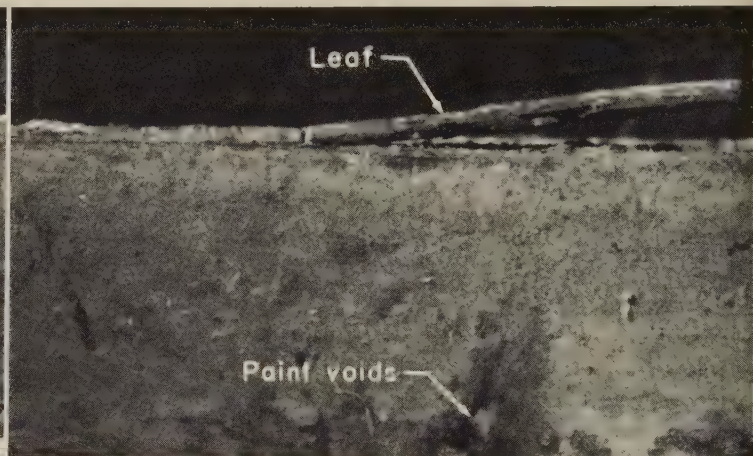
4663 Another portion of the painted external surface of the cap in 4661. Fracture surface, shown in profile at top, contains a "leaf"; compare this view of the "leaf" with that in 4661, which is normal to the fracture surface. As in 4662, paint voids are evident.

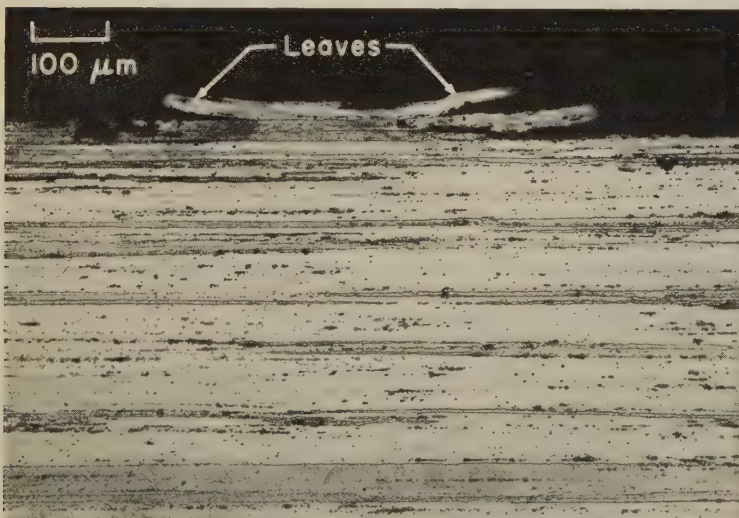
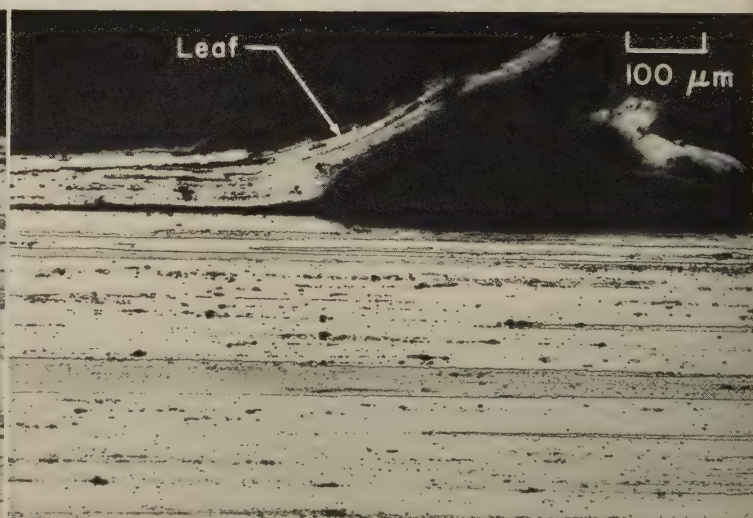
4664, 4665 Polished and etched sections through two portions of the fractured bulkhead cap in 4661, showing "leaves" in the fracture surface (in profile, at top). Note the elongated grains, which are parallel with the fracture surface. Note also that both the primary and secondary cracks are intergranular. Intergranular corrosion has nearly separated several of the "leaves" from the fracture surface. Stress-corrosion cracking was favored by imposition of tensile stresses in installation and by exposure to a marine atmosphere in service.

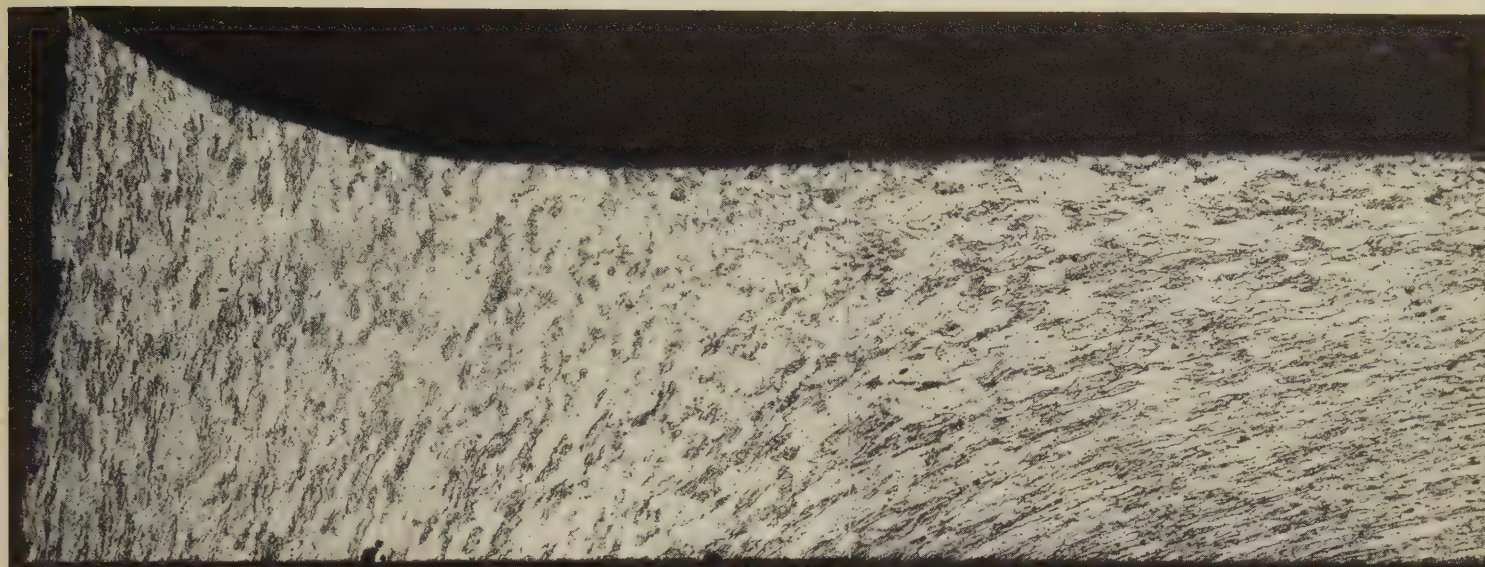
4666 Polished and etched section through the fractured aluminum alloy 7075-T6 bulkhead cap in 4661 (opposite page), showing the fracture surface in profile at left. Note change in grain flow produced during extrusion, from a longitudinal orientation at right to transverse at left; transverse orientation results in grains being parallel to the fracture surface, a condition that aggravates stress-corrosion cracking.

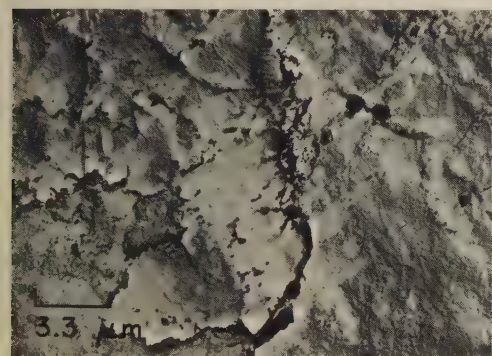
4667 TEM replica of an area of the fracture surface in 4661 near the edge at which fracture was initiated, showing corrosion debris on a very flat intergranular surface. The original separated-grain facets have been corroded away.

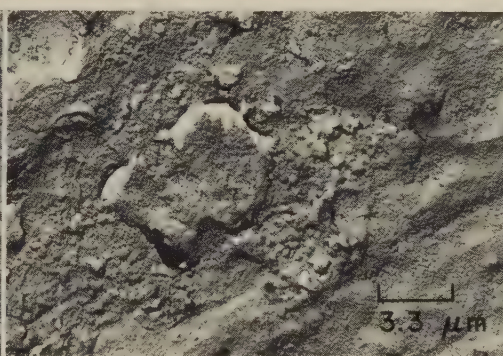
4668 TEM replica taken from another area of the fracture surface in 4661 near the edge at which fracture was initiated. This area, like the one in 4667 (left), shows that cracking was intergranular and was accompanied by severe corrosion.

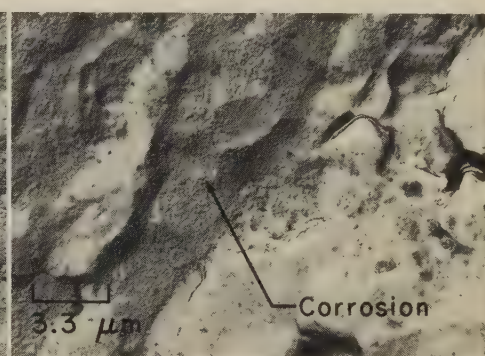
4669 TEM replica of an area of the fracture surface in 4661 deeper into the fracture than 4667 and 4668; here, corrosion of the separated-grain facets is evident, although not as severe as in areas nearer the edge at which fracture was initiated.

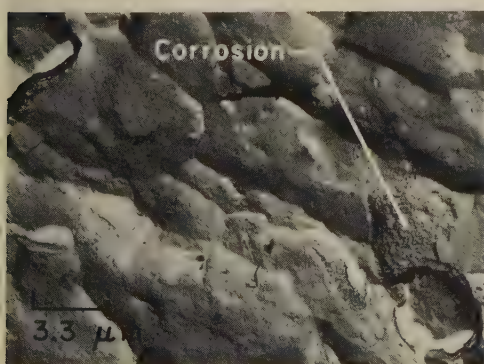
4670 An area of the fracture surface in 4661 still farther from the initiation edge than 4669. This surface, although still intergranular, is relatively free of corrosion products. In a portion of the fracture formed later, evidence of fatigue was found. Final fracture was by shear.

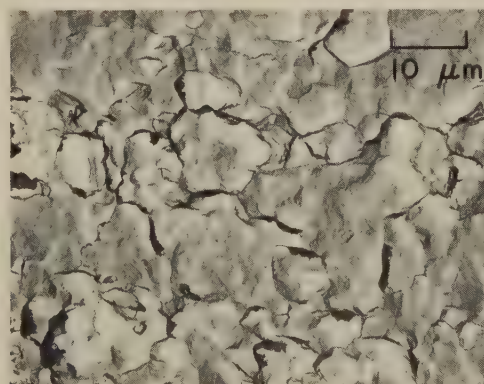
4671 TEM replica of the surface of an intergranular fracture in an aircraft landing-gear component of forged aluminum alloy 7075-T6 that fractured as the result of stress-corrosion cracking. Note the secondary cracks between the grains.

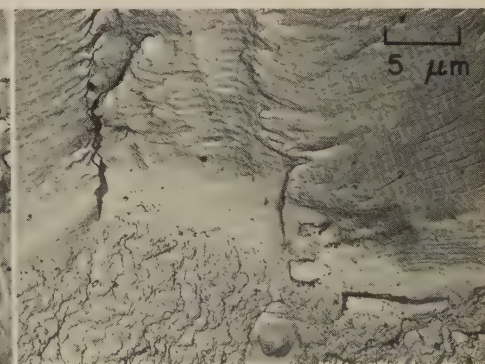
4672 TEM replica of the surface of a fracture in a specimen of aluminum alloy 7075-T6 that first was cracked by fatigue and then was broken by impact. Stretching and serpentine glide are evident at about mid-height, at the root of the fatigue crack; below are tear dimples formed on impact.

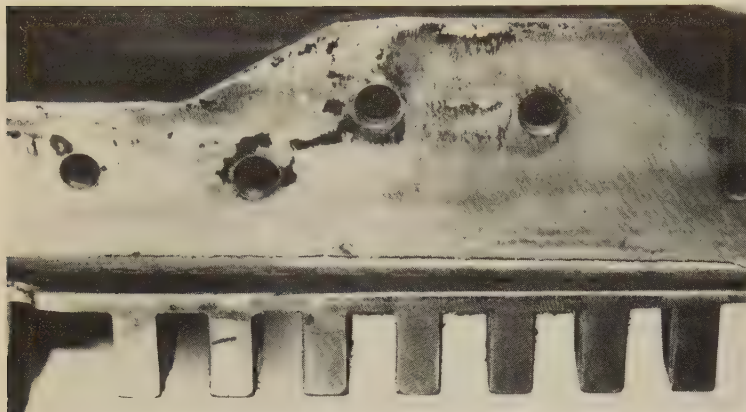
4673 A portion of an aluminum alloy 7079-T6 spar that was machined from a forging. The spar cracked during fatigue testing. The crack is visible as a fine dark horizontal line along the radius of the spar (above nodes). See also fractograph 4674.

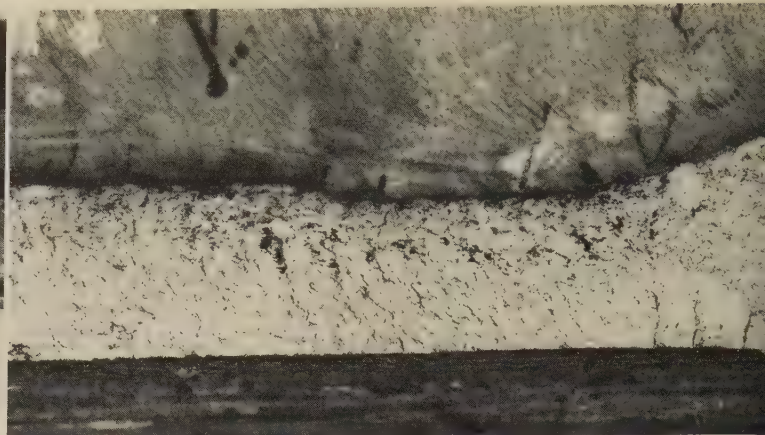
4674 A portion of the surface of the crack in 4673, which was exposed by sectioning. The "clamshell" marks usually observed in fatigue fractures are absent here. See also 4675 to 4684.

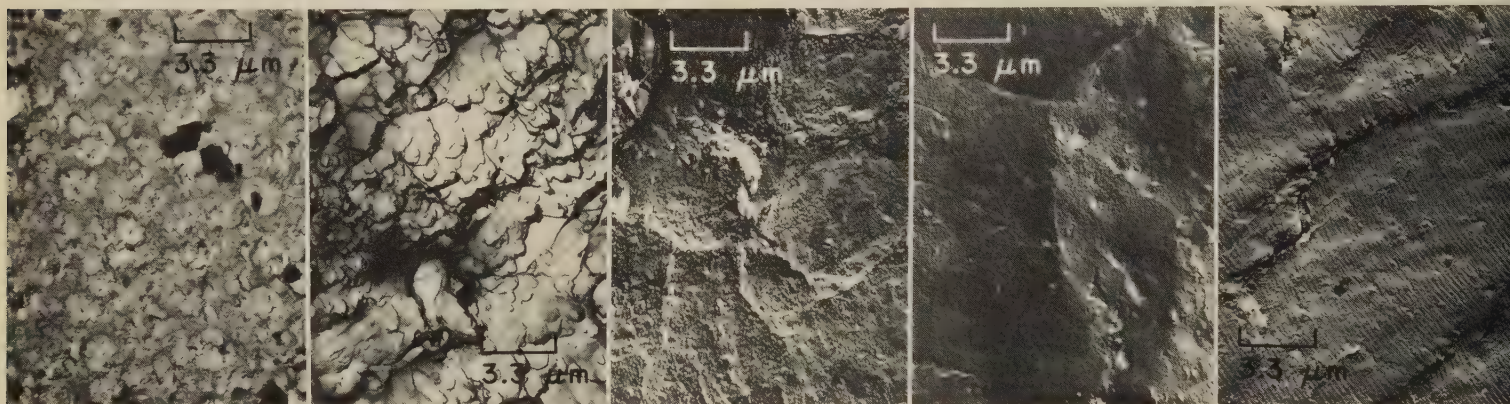
4675, 4676, 4677, 4678, 4679

Fractograph 4675 (left) is a TEM replica of an area 0.002 in. from the outer edge of the crack surface in 4674, showing evidence of corrosion on dimples that were formed by tension overload believed to have occurred during straightening; 4676 (second from left) is a replica of an area near that shown in 4675, displaying shear dimples but no corrosion. Fractograph 4677 (center) is a TEM replica of an area 0.003 in. from the outer edge of the crack in 4674 and shows intergranular facets exposed by stress-corrosion cracking; 4678 (second from right) is a replica of an area near that in 4677, showing similar features. Fractograph 4679 (right) is a replica of an area 0.005 in. from the outer edge of the crack in 4674 and shows striations, which indicate fatigue. See also fractographs 4680 to 4684, below, for TEM views of additional areas of the surface of the crack in 4674.

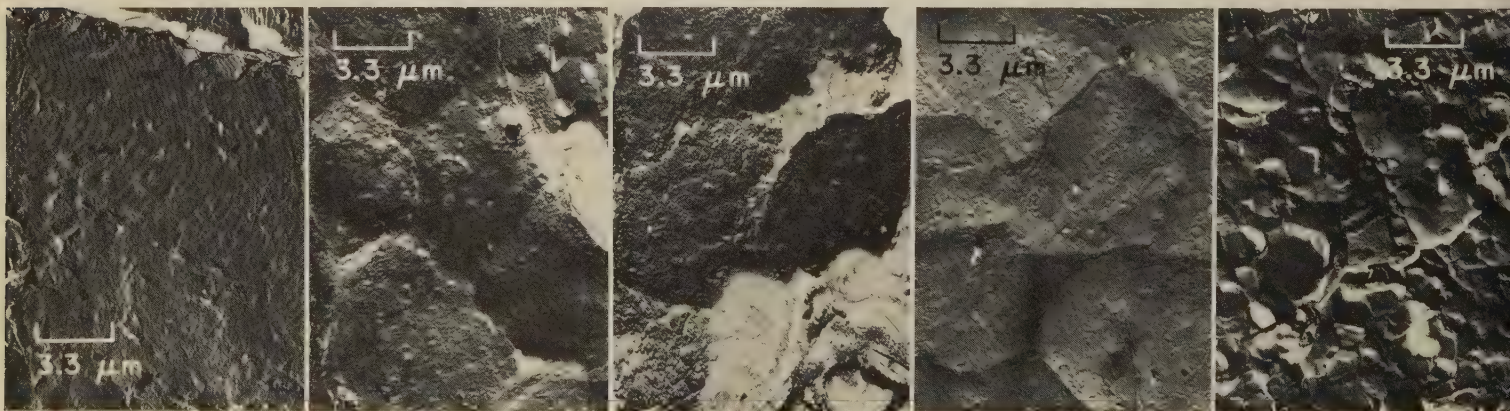
Fractograph 4680 (left) is a TEM replica of an area near that in 4679 (above, right), showing fatigue striations and a region of intergranular facets exposed by stress corrosion. Fractographs 4681 (second from left) and 4682 (center) are replicas of two areas 0.010 to 0.090 in. from the outer edge of the crack in 4674, showing features characteristic of stress-corrosion cracking (separated-grain facets, corrosion products). Fractographs 4683 (second from right) and 4684 (right) are replicas of two areas between the inner crack edge and a point 0.090 in. from the outer edge and show intergranular separation and dimpled transgranular fracture respectively; tension-overload features were observed throughout the remainder of the fracture.

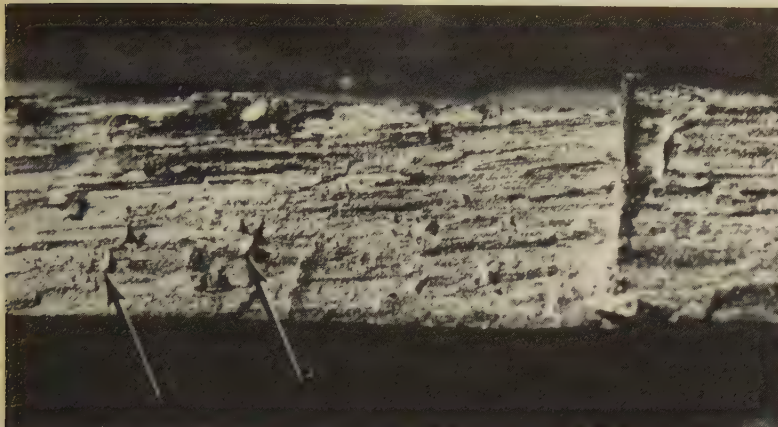
4685 Surface of a stress-corrosion fracture in an aluminum alloy 7079-T6 spar that cracked in service in a marine atmosphere. The arrows at left indicate locations of "leaves" that were formed by intergranular splintering. Hardness was Rockwell B 91. See 4686 to 4688.

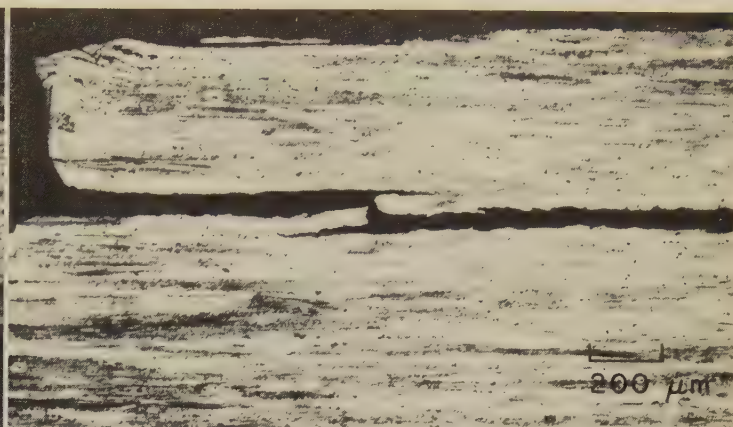
4686 A polished and etched section through the fractured spar in 4685, showing a "leaf" in the fracture surface (at top). The intergranular cracks that formed such "leaves" were 0.002 to 0.010 in. below the main fracture surface.

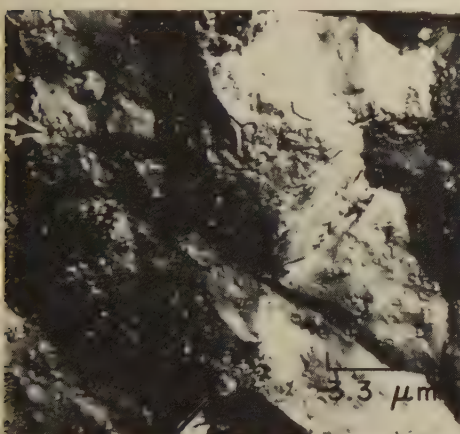
TEM fractograph (p-c replica)

3000×

4687 TEM replica of an area of the fracture surface shown in fractograph 4685 (above). This area exhibits intergranular facets that were exposed by stress-corrosion cracking; the facets carry appreciable corrosion products, such as at arrow at upper left edge. See also 4688.

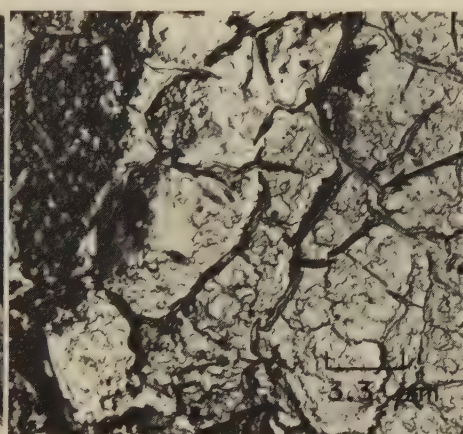
TEM fractograph (p-c replica)

3000×

4688 TEM replica of another area of the fracture surface in 4685. Like 4687, this replica shows features of intergranular stress corrosion. Pronounced "mud cracks", such as those at arrow, are evident also. Some local regions of the fracture (not shown) contain dimples.

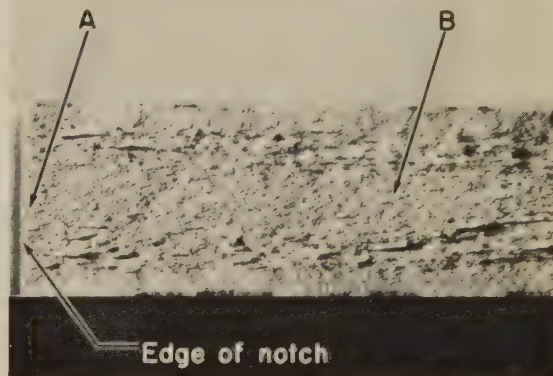
Light fractograph

Actual size

4689 Surface of a tension-overload fracture in a centrally notched plate (64 in. by 20 in. by 1 in. thick) of aluminum alloy 7079-T651. Tensile strength was 565 MPa (82 ksi). Fracture occurred at a net stress of 165 MPa (24 ksi). Notch was 0.005 in. in radius by 7 in. long by plate thickness. The fracture surface is relatively flat but contains jagged features. See 4690 to 4692 for views at A and B.

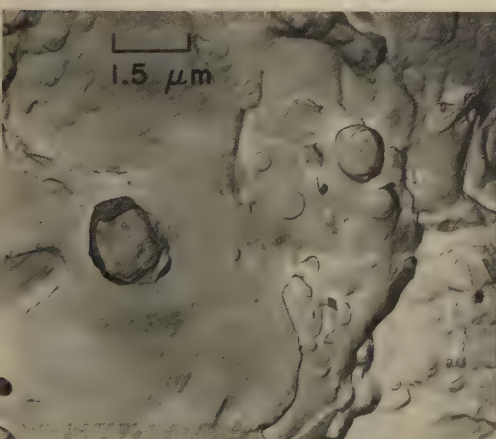
TEM fractograph (p-c replica)

6500×

4690 TEM replica of an area at A, at the notch, in 4689, showing dimples of various sizes, large stretched regions, and some serpentine glide. See 4691.

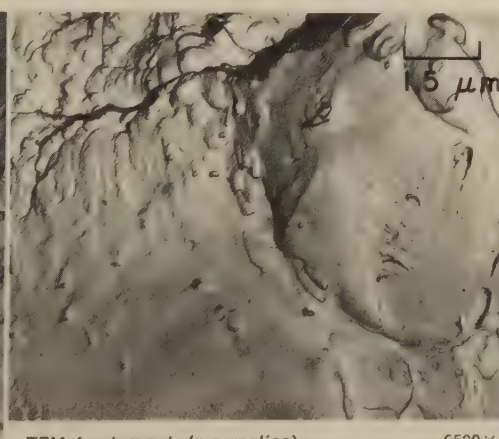
TEM fractograph (p-c replica)

6500×

4691 TEM replica of another area at A in 4689. Like 4690, this replica shows large stretched regions and dimples of various sizes. Two facets near bottom right in this view suggest cleaved second-phase particles.

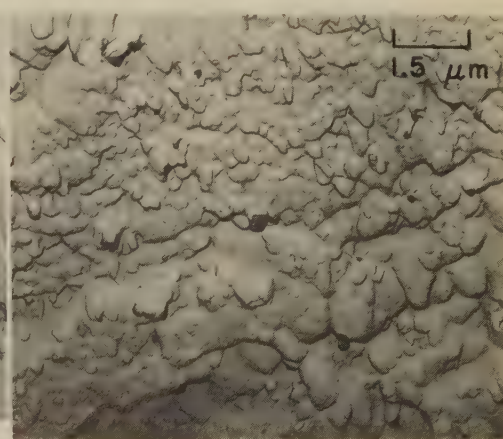
TEM fractograph (p-c replica)

6500×

4692 TEM replica of an area at B, about 2 in. from the notch, in 4689. Fracture here shows elongated dimples of various sizes, all oriented in the same general direction.

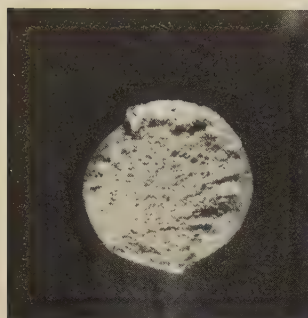
Light fractograph 3½×

4693 Tension-overload fracture in an unnotched specimen of beryllium copper (2% Be) aged at 316 C (600 F) to a tensile strength of 1327.9 MPa (192.6 ksi) and broken at room temperature. A shear lip is visible at top. See also 4694 to 4697.

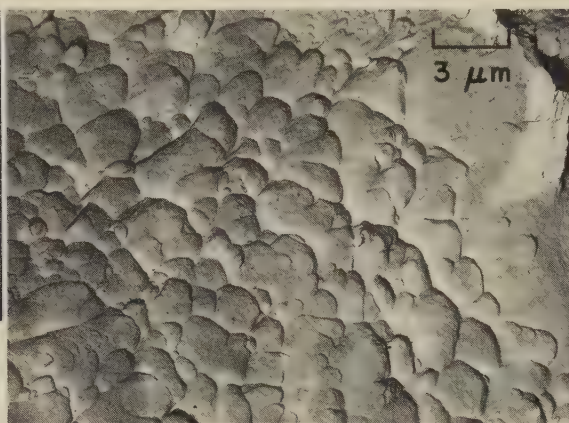
TEM fractograph (p-c replica) 3300×

4694 TEM replica of an area in the shear lip at the edge of the fracture surface in 4693, showing rather uniformly sized shear dimples. There appear to be regions of stretching (top right) and a small region of serpentine glide (right edge).

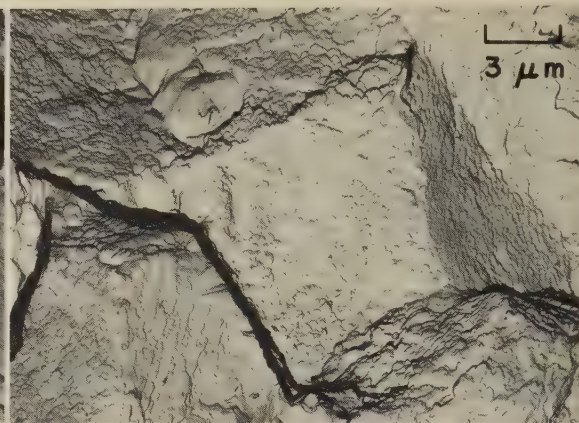
TEM fractograph (p-c replica) 3300×

4695 TEM replica of an area at the center of the fracture surface in 4693, showing rather massive intergranular facets, with very fine dimples on many of the facets. A region containing transgranular facets is visible at top center.

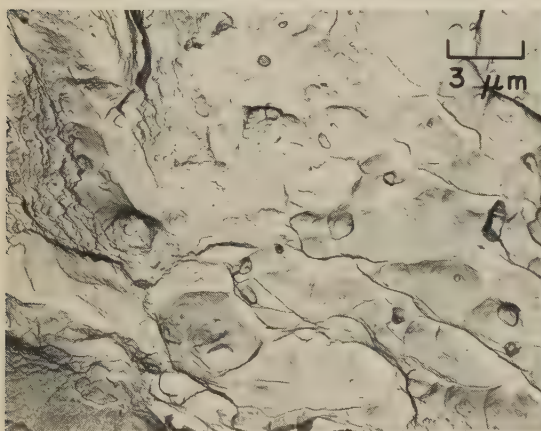
TEM fractograph (p-c replica) 3300×

4696 TEM replica of another area at the center of the fracture surface in 4693, showing dimples on transgranular facets (at right) and on intergranular facets (at left).

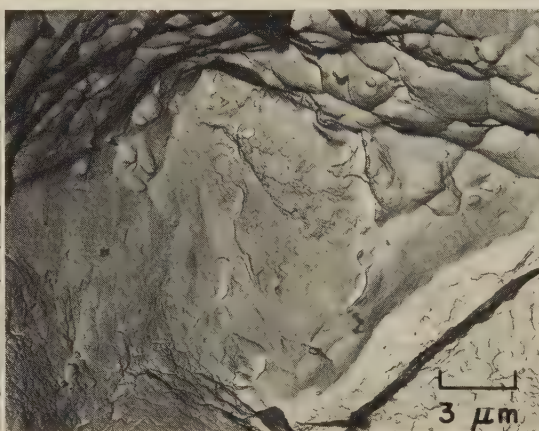
TEM fractograph (p-c replica) 3300×

4697 A third area at the center of the fracture surface in 4693, displaying very large intergranular facets in the lower portion and a region of dimples above.

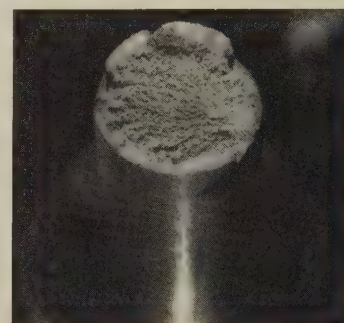
Light fractograph 3½×

4698 Tension-overload fracture in an unnotched specimen of beryllium copper (2% Be) aged at 316 C (600 F) to a tensile strength of 1327.9 MPa (192.6 ksi) and tested at 260 C (500 F). Note shear lip at top. See also 4699 to 4701.

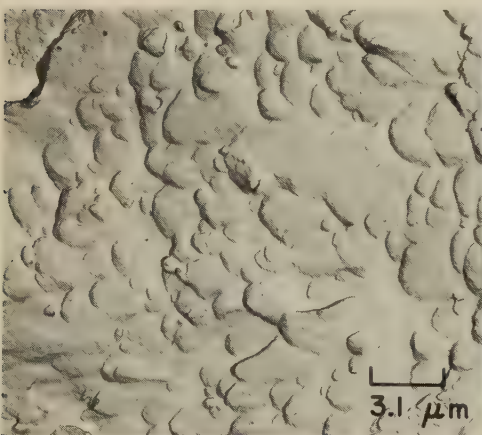
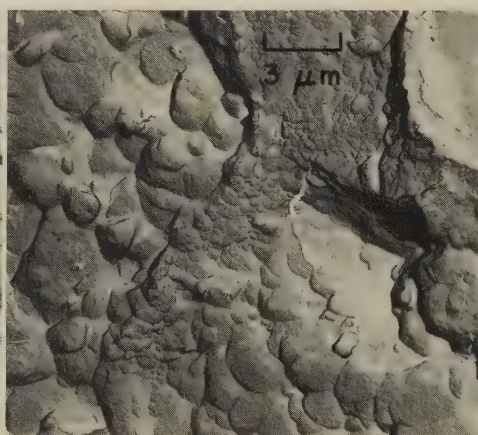
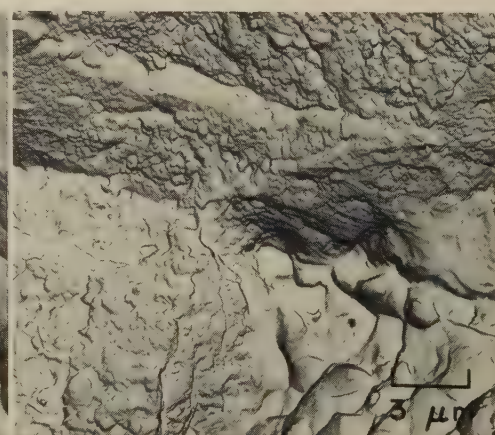
4699, 4700, 4701

TEM replicas of three areas of the fracture surface in 4698. Fractograph 4699 (left), of an area in the shear lip at the edge of the fracture surface, reveals relatively flat shear dimples and regions of very small dimples. Fractograph 4700 (center), of an area near (but not at) the edge of the fracture surface, shows a mixture of regions of shear dimples and regions of dimpled intergranular facets. Fractograph 4701 (right) is of an area at the center of the fracture surface; except for regions of transgranular shear dimples at lower right, this area shows features of intergranular dimpled rupture and is typical of the entire central zone of the fracture surface.

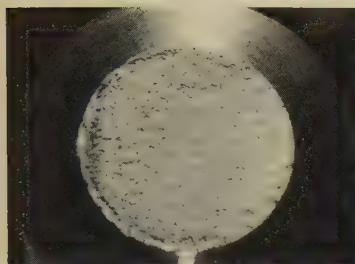
Light fractograph 334×
4702 Low-cycle fatigue fracture in a notched specimen of beryllium copper (2% Be) aged to a tensile strength of 1327.9 MPa (192.6 ksi) and loaded at room temperature to a stress cycled from 83 to 414 MPa (12 to 60 ksi) at 500 cycles per minute. Fracture occurred after 1700 cycles. Notch had a 60° angle, 0.30-in. diam, 0.008-in. root radius. See also 4703 to 4705.

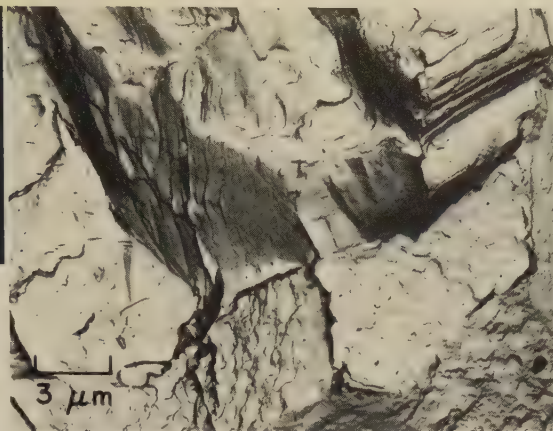
TEM fractograph (p-c replica) 3300×
4703 TEM replica of an area at a crack nucleus at the root of the notch in 4702. Regions of fatigue striations are interspersed with dimpled intergranular facets, some of which show marks that are probably fissures.

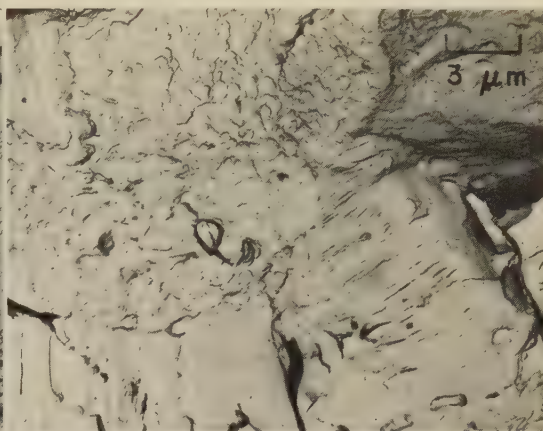
TEM fractograph (p-c replica) 3300×
4704 TEM replica of an area near, but not at, a crack nucleus in the fracture surface in 4702, displaying dimpled intergranular facets (at top), and fatigue patches (below) at strikingly different orientations.

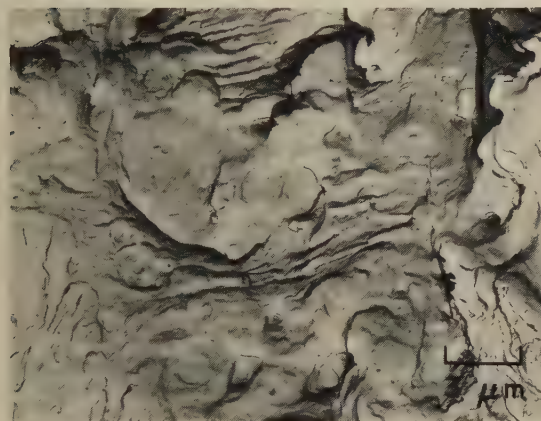
TEM fractograph (p-c replica) 3300×
4705 TEM replica of an area of the fracture surface in 4702, at the transition from fatigue to fast fracture, showing fatigue striations at top, a dimpled intergranular facet at lower right, and rather smooth areas elsewhere.

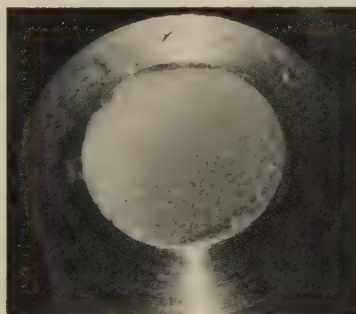
Light fractograph 31/2×
4706 High-cycle fatigue fracture in a notched specimen of beryllium copper (2% Be) loaded at 260 C (500 F) to a stress cycled from 83 to 414 MPa (12 to 60 ksi) at 500 cycles per minute. Fracture occurred after 3200 cycles. Tensile strength and notch same as for 4702. See 4707 to 4710.

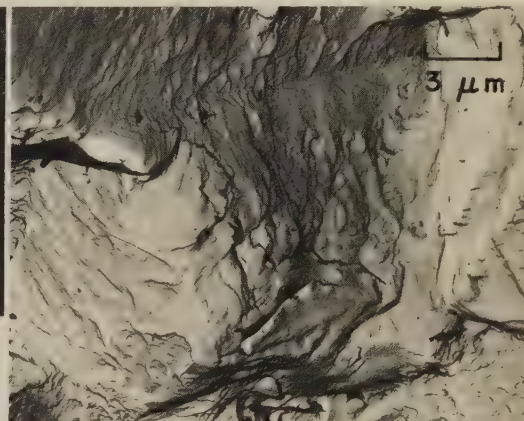
TEM fractograph (p-c replica) 3300×
4707 TEM replica of an area at a crack nucleus at the root of the notch in 4706, showing intergranular facets. Very few of the marks that are visible in this area can be positively identified as fatigue striations.

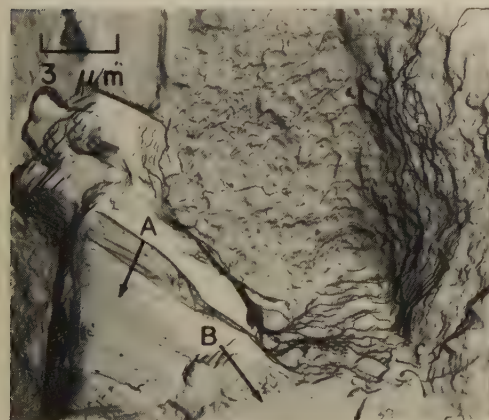
TEM fractograph (p-c replica) 3300×
4708 TEM replica of an area near, but not at, a crack nucleus in 4706, showing fatigue striations that exhibit striking differences in alignment from A to B and that are interspersed with dimpled intergranular facets.

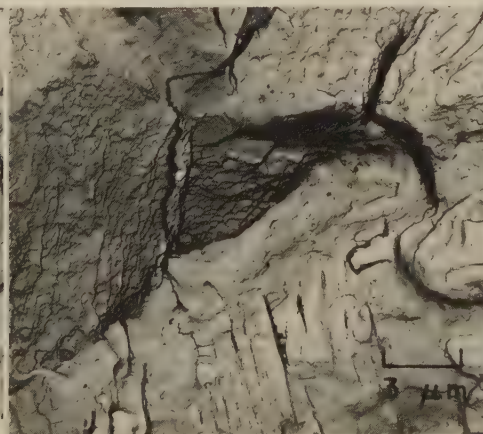
TEM fractograph (p-c replica) 3300×
4709 TEM replica of an area near the transition from fatigue to fast fracture in 4706, showing dimpled intergranular facets in general and suggestions of fissures or striations at bottom.

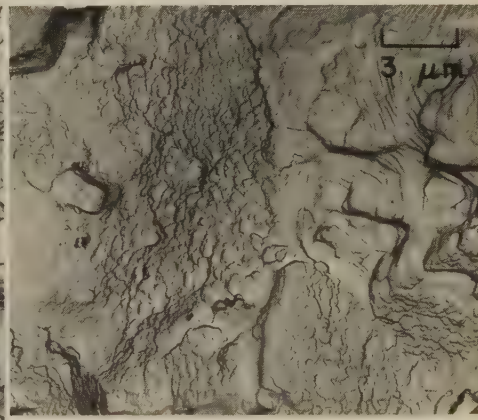
TEM fractograph (p-c replica) 3300×
4710 TEM replica of an area at the transition from fatigue to fast fracture in 4706. Curved striations with several orientations are visible at upper right; the remainder of the area consists of dimpled intergranular facets.

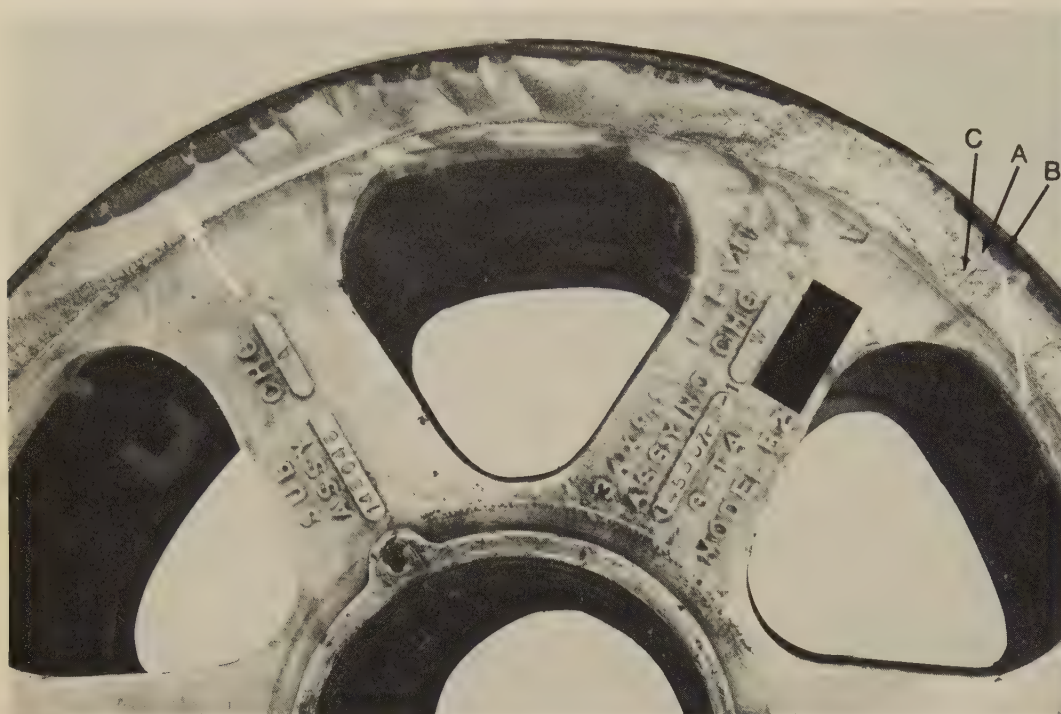
Photograph

4711 Portion of an aircraft landing wheel of sand cast magnesium alloy AZ81A-T4, showing a corrosion-fatigue fracture that occurred in service at the locking-ring channel. Nominal tensile strength was 276 MPa (40 ksi). The fracture extended halfway around the perimeter of the wheel. Many discolored, crescent-shaped fatigue-crack nuclei were found; two are indicated by white arrows. See 4712 to 4715 for TEM views of areas at A, B and C.

0.3×

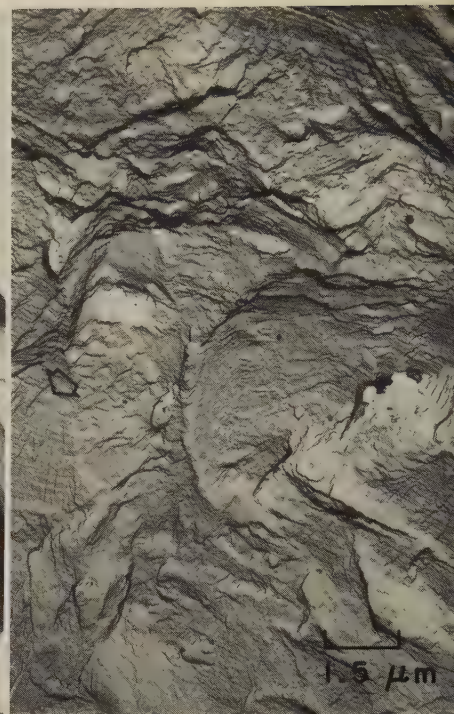
TEM fractograph (p-c replica)

6500×

4712 TEM replica of an area at the fatigue-crack nucleus at A in the fracture surface in 4711, showing "brittle" fatigue striations (such as at the arrow at left center).

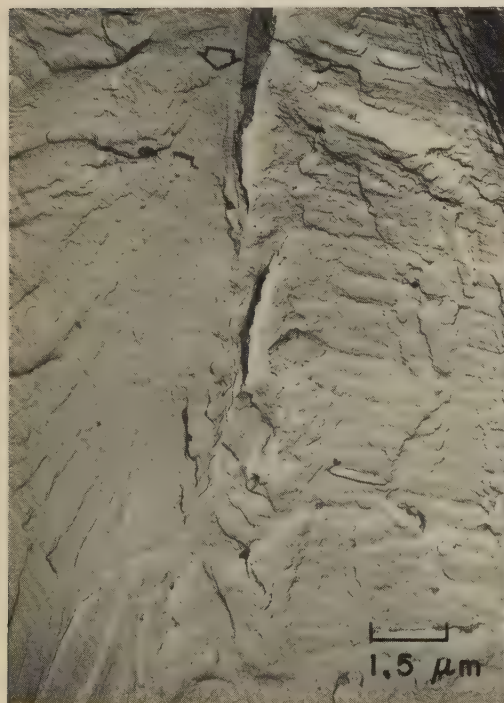
TEM fractograph (p-c replica)

6500×

4713 TEM replica of another area at A in 4711. Fine, roughly horizontal striations are visible in a fatigue patch at the arrow at top center; the marks at the right include widely spaced horizontal fissures.

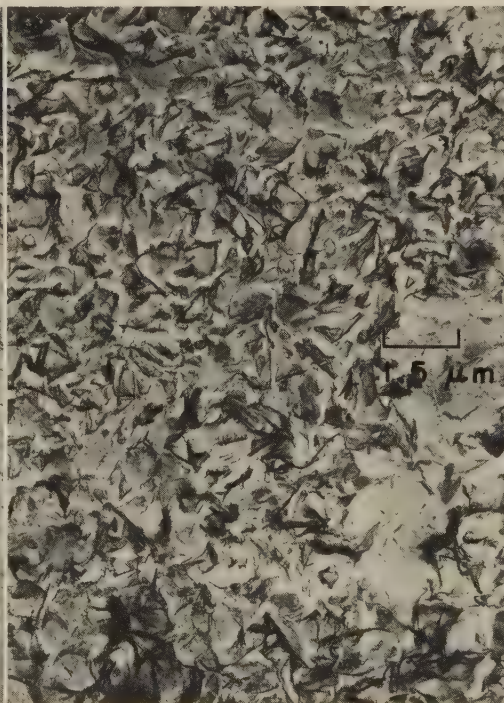
TEM fractograph (p-c replica)

6500×

4714 TEM replica of an area at B in 4711. In this area, the fracture surface is largely obscured by corrosion products. The few facets that are visible have essentially no distinguishable features.

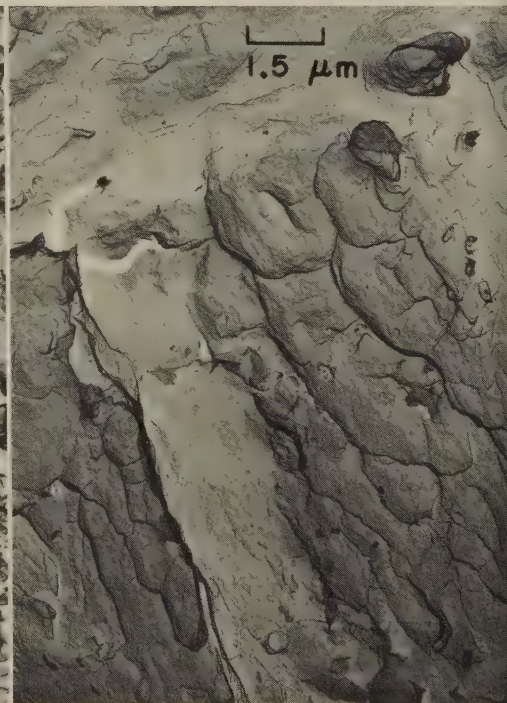
TEM fractograph (p-c replica)

6500×

4715 TEM replica of an area at C in 4711, in the region of final, fast fracture. This area exhibits rather flat, elongated dimples. The region at left center in this view appears to have been stretched.

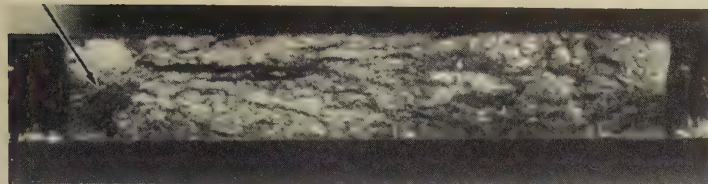
Light fractograph

9×

4716 Surface of a tension-overload fracture in a notched specimen of stress-relieved TZM alloy (Mo-0.5Ti-1.0Zr) sheet. Unnotched tensile strength was 972 MPa (141 ksi). The specimen was notched on each edge to a depth of 0.1 in. with a jeweler's saw and broken at room temperature; notched tensile strength was 1007 MPa (146 ksi). Fracture produced distinct flat regions at the origins of each notch. See 4717 and 4718 (below) for TEM replicas of areas at the arrow.

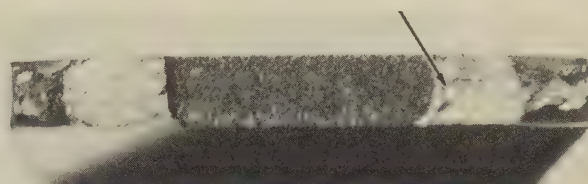
Light fractograph

6×

4719 Surface of a high-cycle fatigue fracture in a stress-relieved specimen of 90Ta-10W alloy sheet containing a central transverse notch 0.2 in. wide. Tensile strength was 552 MPa (80 ksi). The specimen was loaded in tension at room temperature to a stress cycled from 80 to 400 MPa (11.6 to 58 ksi) at 1000 cycles per minute and broke after 15,900 cycles. Considerable necking accompanied fast fracture. See also fractographs 4720 and 4721 (below), for TEM replicas of areas at the arrow.

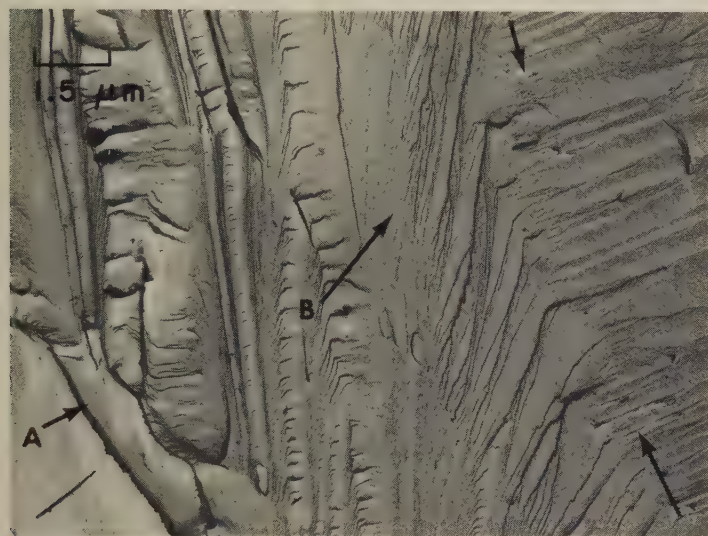
TEM fractograph (p-c replica)

6500×

4717 TEM replica of an area at the arrow in 4716 (above). Here, the fracture surface shows transgranular cleavage. A tilt boundary at A; elsewhere, twist boundaries (between arrows) and suggestions of cleavage feather marks (at B).

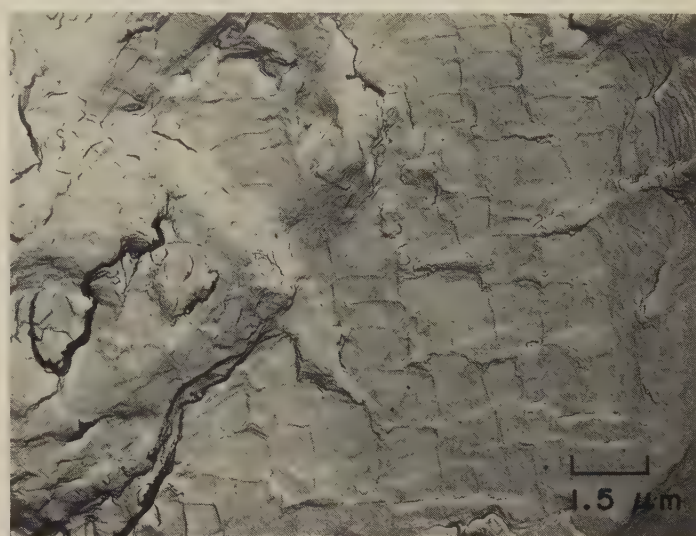
TEM fractograph (p-c replica)

6500×

4720 TEM replica of an area at arrow in 4719 (above). A few fatigue striations are visible at top and at right. Remainder of surface here is unusual, consisting of what appear to be very flat-bottomed, shallow dimples.

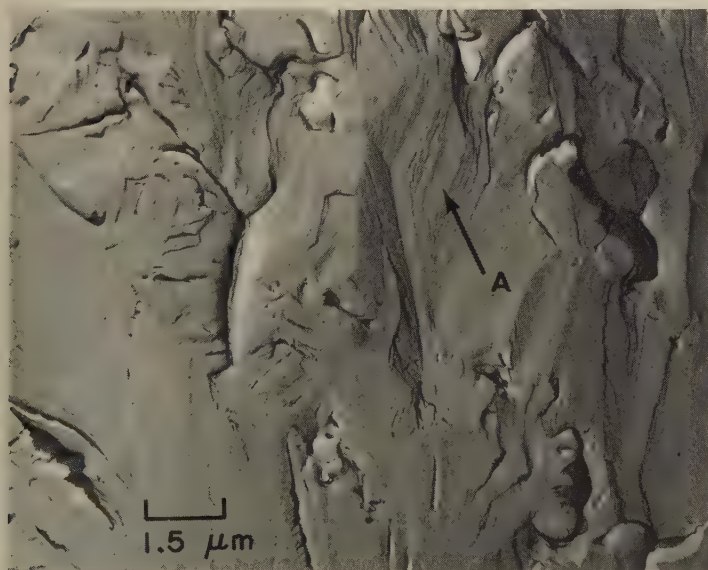
TEM fractograph (p-c replica)

6500×

4718 TEM replica of another area at the arrow in 4716 (above). The features visible here are cleavage facets with involved steps but few clear river patterns. The features at A bear some resemblance to feather marks.

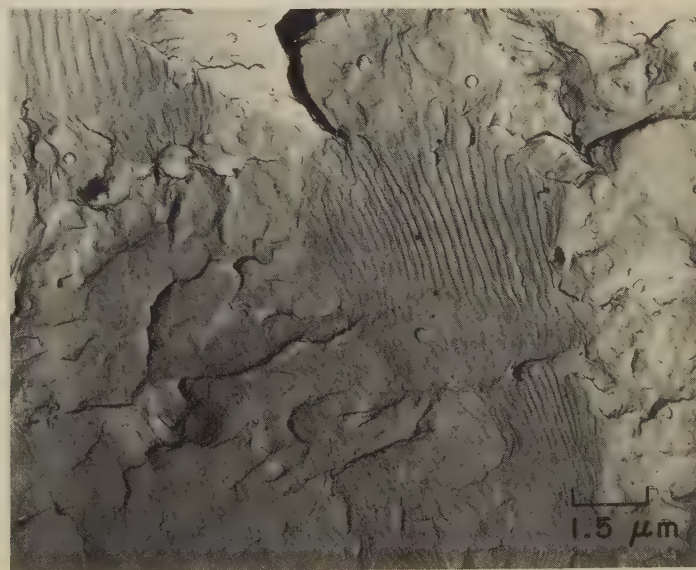
TEM fractograph (p-c replica)

6500×

4721 TEM replica of another area at the arrow in 4719 (above), showing distinct fatigue striations at center and at upper left. Elsewhere, the surface bears scattered and indistinct marks that resemble fatigue striations.

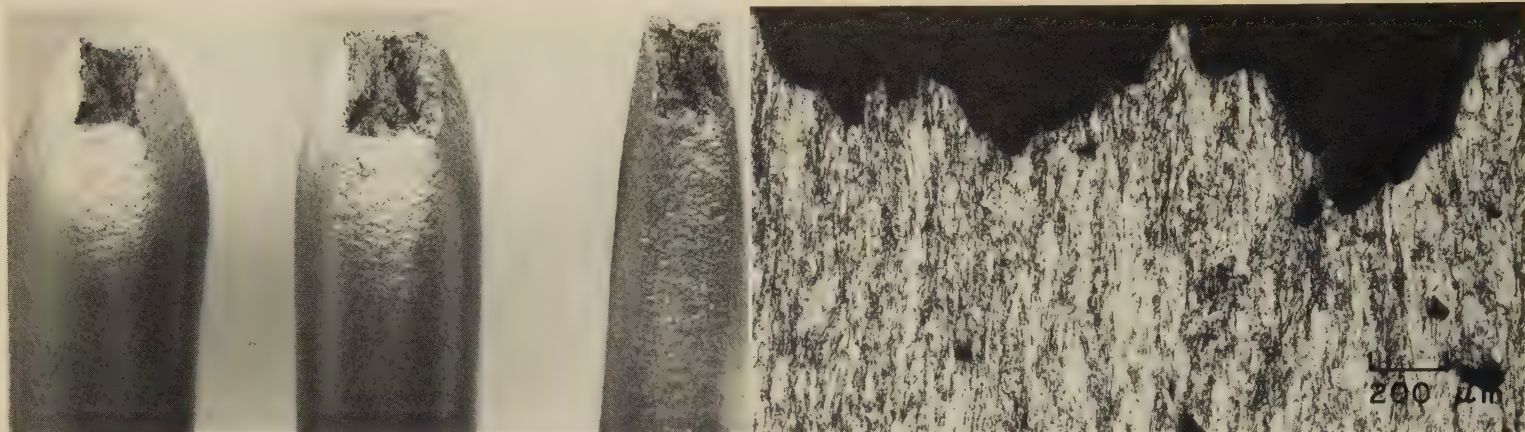
Photograph

2×

4722 Three specimens of vacuum annealed unalloyed titanium that were broken in a tension test. The specimen at center was tested in air at room temperature; the specimen at left was tested in vacuum at 500 C (932 F); the specimen at right was tested in vacuum at 580 C (1076 F). See also 4723 to 4726.
